First experience of ^{192}Ir source stuck event during high-dose-rate brachytherapy in Japan

Purpose: To share the experience of an iridium-192 (^{192}Ir) source stuck event during high-dose-rate (HDR) brachytherapy for cervical cancer.

Material and methods: In 2014, we experienced the first source stuck event in Japan when treating cervical cancer with HDR brachytherapy. The cause of the event was a loose screw in the treatment device that interfered with the gear reeling the source. This event had minimal clinical effects on the patient and staff; however, after the event, we created a normal treatment process and an emergency process. In the emergency processes, each staff member is given an appropriate role. The dose rate distribution calculated by the new Monte Carlo simulation system was used as a reference to create the process.

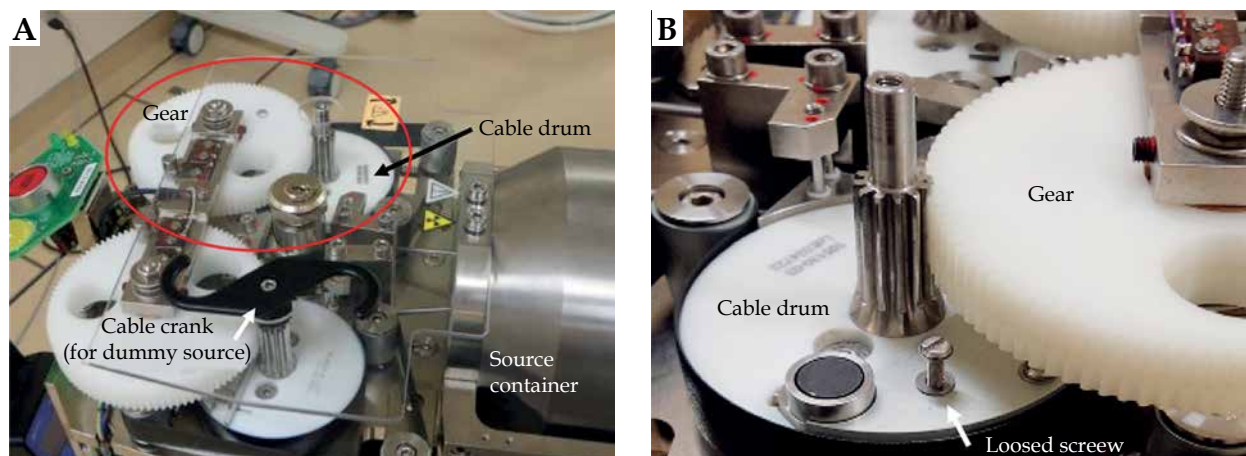
Fig. 1. A) Structure of the microSelectron HDR v2 head region and a closeup of the cable drum and gear. The circle in the schema corresponds to (B). B) A closeup of the gear and cable drum with the loose screw

the tube at 1400–1480 mm from the transport start point. However, this friction was not proven to be the cause of the accident. Third, the performance of the emergency circuit of the treatment device was evaluated, and it was confirmed that the circuit functioned properly with reproducibility. Finally, the loose screw found in the cable drum was evaluated. The source cable has a mechanism to wind up by rotating the cable drum and crank (Figure 1A). However, as shown in Figure 2, the gear on the cable drum was discovered to be scratched. Thus, based on the findings of the detailed investigation, the cause of the event was found to be the loose screw that interfered with the gear (Figure 1B). Furthermore, this screw was considered to have been loose 3 months before the event occurred.

The cause of this event was determined to be the interference of loose screws and gears. The loosening of the screw was considered to have occurred 3 months before. However, the quality control conducted on the day of the event and the regular inspections were properly implemented. Unexpected events can occur at any time, even if quality control has been successfully implemented [19]. Naturally, the possibility of occurrence of rare cases such as this event is very low. However, the occurrence of such events cannot be completely avoided. Therefore, it is important to prepare for an emergency response at any time.

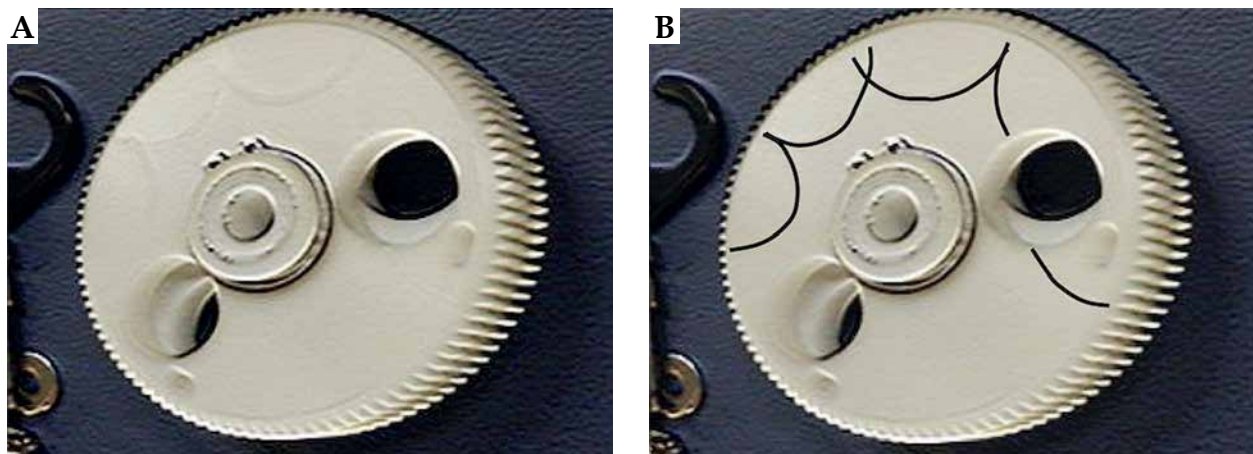
Fig. 2. The notch on the cable drum gear (edge emphasis processing was performed). The right figure shows the trace of the notch (black lines were traced by the author)
