First experience of ^{192}Ir source stuck event during high-dose-rate brachytherapy in Japan

Purpose: To share the experience of an iridium-192 (^{192}Ir) source stuck event during high-dose-rate (HDR) brachytherapy for cervical cancer.

Material and methods: In 2014, we experienced the first source stuck event in Japan when treating cervical cancer with HDR brachytherapy. The cause of the event was a loose screw in the treatment device that interfered with the gear reeling the source. This event had minimal clinical effects on the patient and staff; however, after the event, we created a normal treatment process and an emergency process. In the emergency processes, each staff member is given an appropriate role. The dose rate distribution calculated by the new Monte Carlo simulation system was used as a reference to create the process.

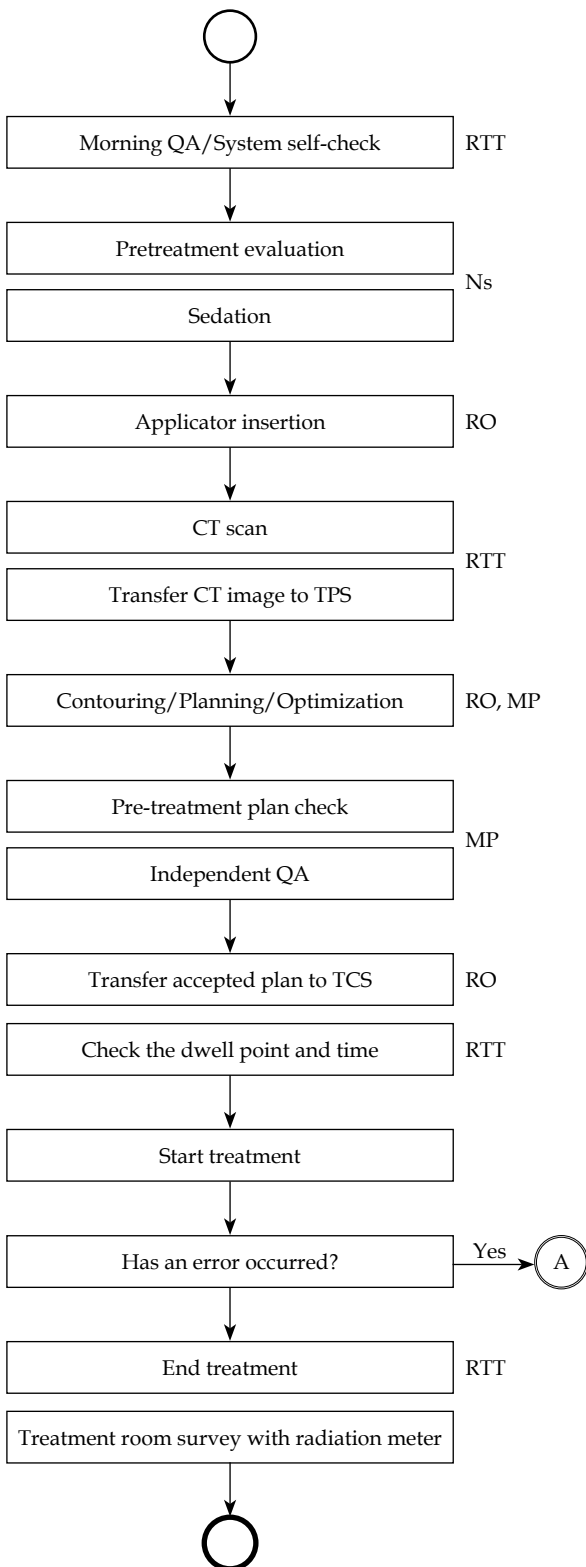
The normal treatment process is shown in Figure 3. This process was conducted by 4 experts: RO, MP, RTT, and Ns. In the treatment planning, CTV, bladder, rectum,

Fig. 3. Process map for cervical cancer treatment. The circle indicates the start of the process. The circle in bold indicates the end of the process. The circle “A” corresponds to an emergency process start. RO - radiation oncologist, MP - medical physicist, RTT - radiation therapy technologist, Ns - nurse

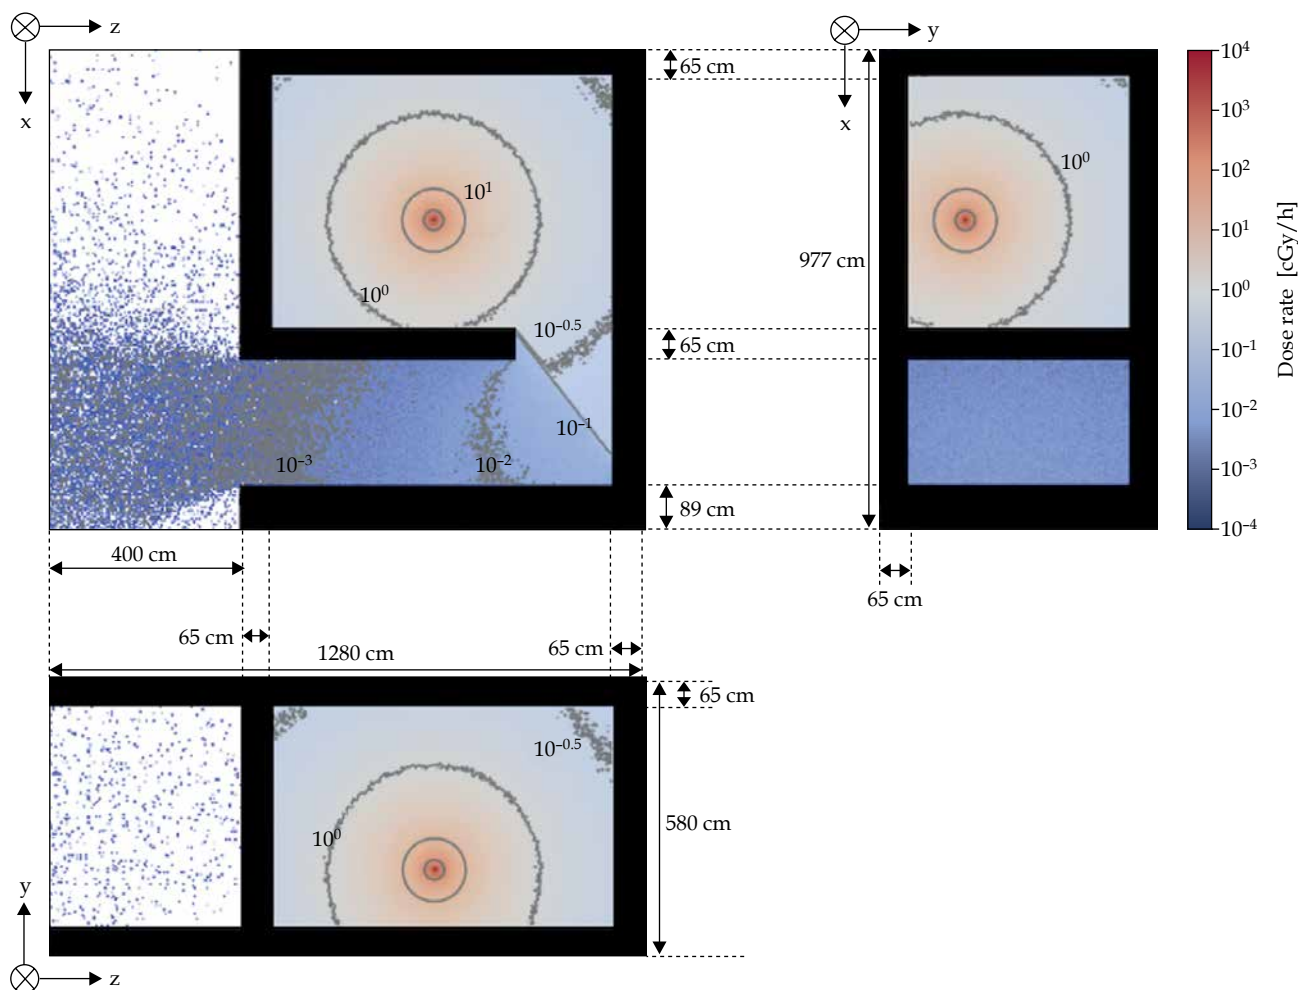
Figure 4 shows the dose rate distributions in the treatment and console rooms calculated by the FDEIR system. The air kerma rates of the internal maze inside the treatment room maze, near the entrance to the treatment room, and near the console room were estimated to be $\cong 10^{-2}$ [cGy · h⁻¹], $\cong 10^{-3}$ [cGy · h⁻¹], and $\ll 10^{-3}$ [cGy · h⁻¹], respectively.

Fig. 4. Dose rate distribution of the ¹⁹²Ir source in the irradiation and console rooms with the door opened. The black region indicates the concrete region

The dose rate near the source container was estimated to be 1.000 ± 0.115 [cGy · h⁻¹] under the FDEIR system and 0.935 [cGy · h⁻¹] in actual measurement. Furthermore, the dose rate at the inner maze was estimated to be $4.0 \times 10^{-3} \pm 1.5 \times 10^{-3}$ [cGy · h⁻¹] under the FDEIR system and 5.9×10^{-3} [cGy · h⁻¹] in actual measurement.

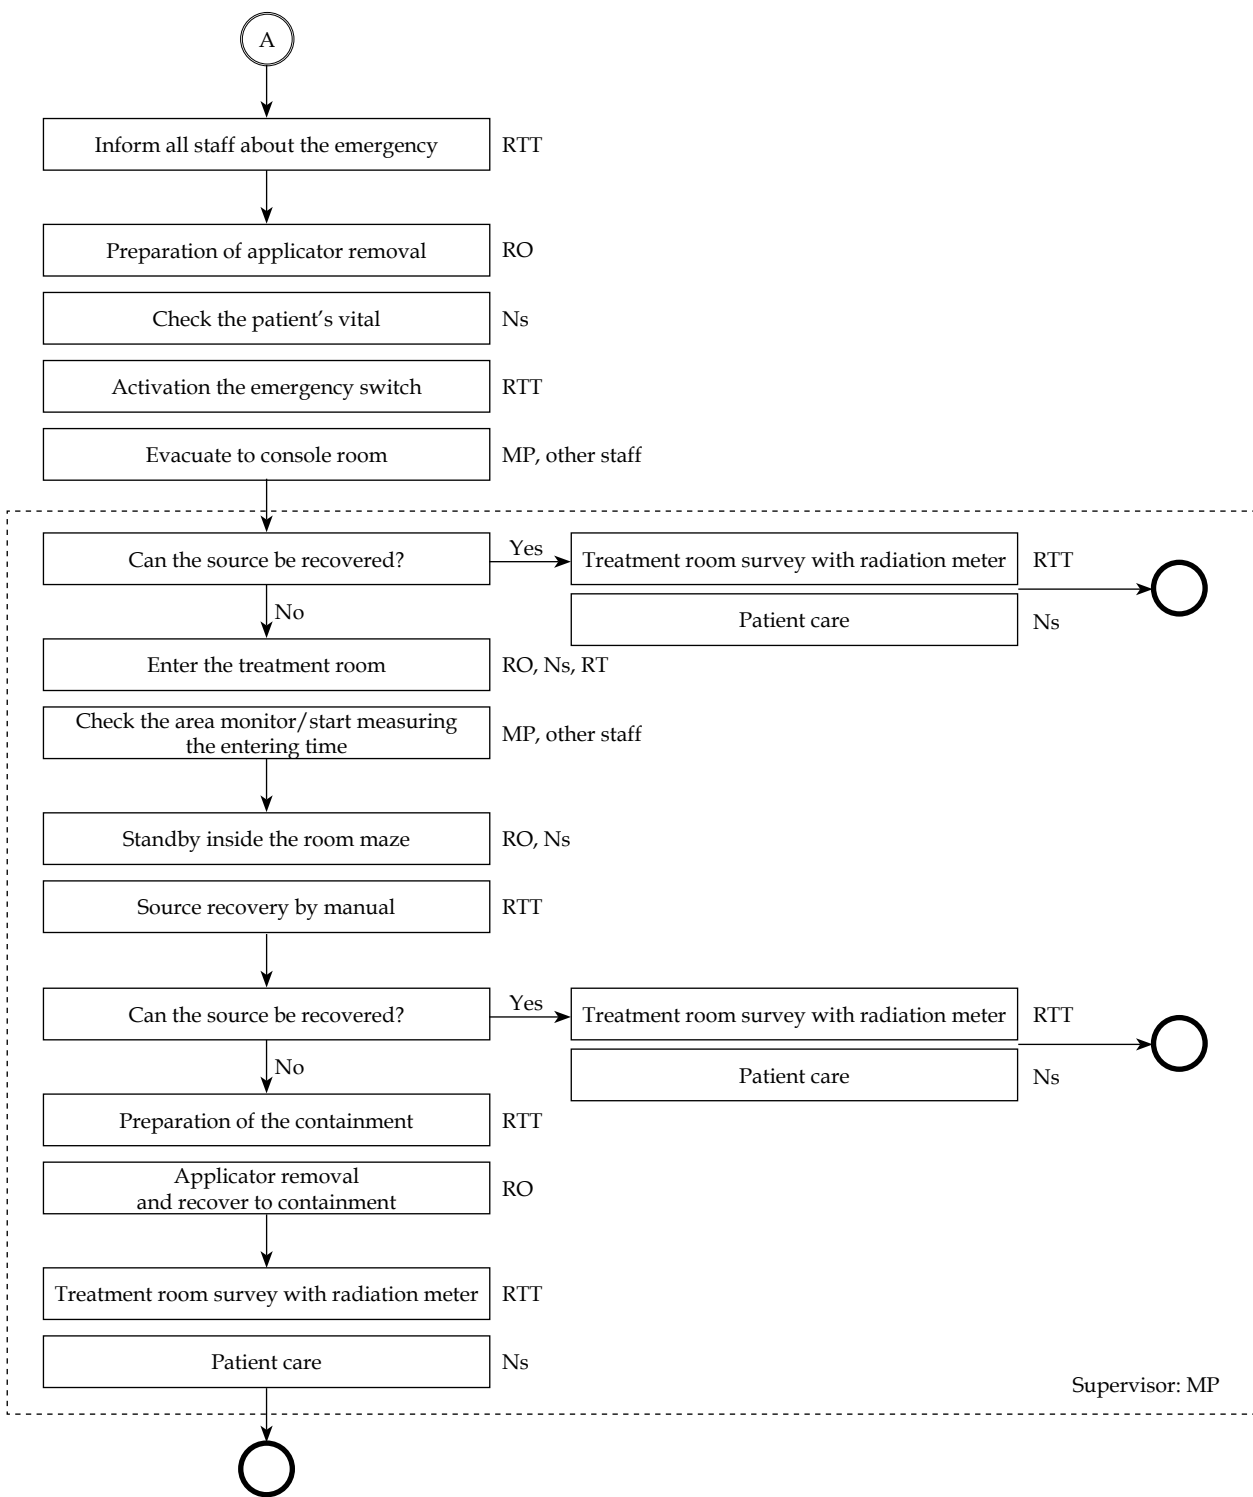
The emergency process is shown in Figure 5. This process began by transferring event occurrences from the RTT to other staff members. Three key persons (RO, RTT, and Ns) prepared for patient rescue. Other staff (such as MP) prepared the records and evacuated to the console room. According to the simulation, the console room was confirmed to have almost no effect of the radiation source even when the entrance door to the room was opened. First, the RTT activated the TCS emergency stop mechanism. However, if the mechanism did not function properly, the rescuer entered the treatment room, and thus, the RTT manually attempted to recover the source. Meanwhile, the RO and Ns waited inside the maze of the treatment room where the influence of the radiation source

Fig. 5. Emergency process map. The circle “A” indicates the start of the process. The circle in bold indicates the end of the process. RO – radiation oncologist, MP – medical physicist, RTT – radiation therapy technologist, Ns – nurse
